Manhole Inspection Summary

Manhole # S37K__003MH

Insp Date: **8/13/08 12:01 PM**

Location Address: **rear 621 e pratt**

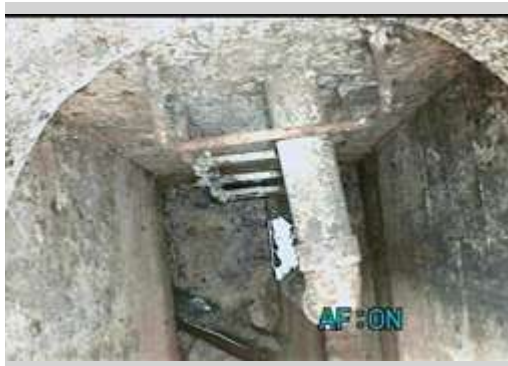
Defect 2

Condition: ☐ Sound ☐ Cracked ☐ Root Intrusion ☐ Deteriorated ☐ Leaks ☒ **Debris**

Count: **5** Missing: **0** ☒ **Corroded**

corroded steps, bench debris

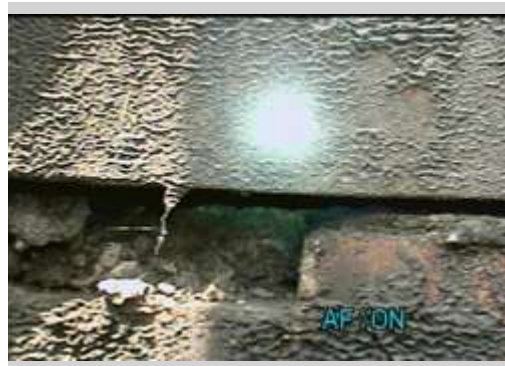
Defect 1

Condition: ☐ Sound ☐ Cracked ☐ Root Intrusion ☒ **Loose Brick** ☒ **Deteriorated**

Infiltration: ☐ None ☒ **Joint** ☐ Cracks ☐ Mortar ☐ Roots ☐ Wall

loose bricks and deteriorated chimney,
joint infiltration

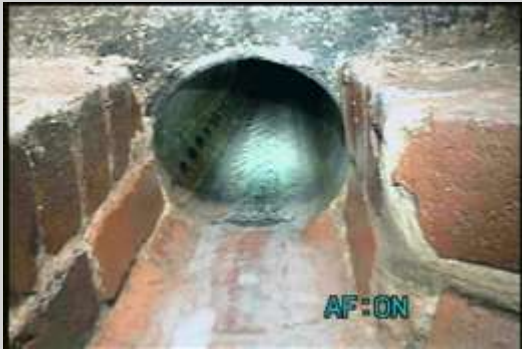
12 O'Clock Outflow

8 in. Circular Gravity Sewer
Pipe Out @ 12 O'Clock

Pipe Material: **Clay** ☐ Pipe Lined

Invert Depth: **8.92** (ft.) Flow Characteristics: **Fast**

Infiltration: **None** Pipe Seal Cond: **Unknown**

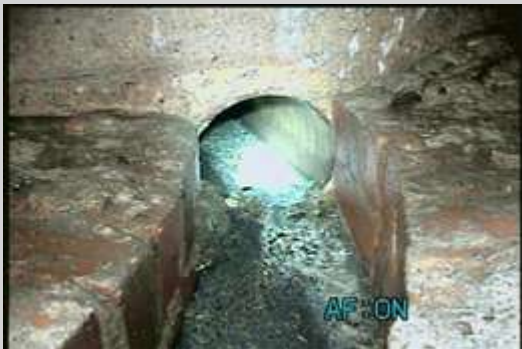
3 O'Clock Inflow

8 in. Circular Gravity Sewer
Pipe In @ 3 O'Clock

Pipe Material: **Clay** ☐ Pipe Lined

Invert Depth: **8.83** (ft.) Flow Characteristics: **None**

Infiltration: **None** Pipe Seal Cond: **Unknown**

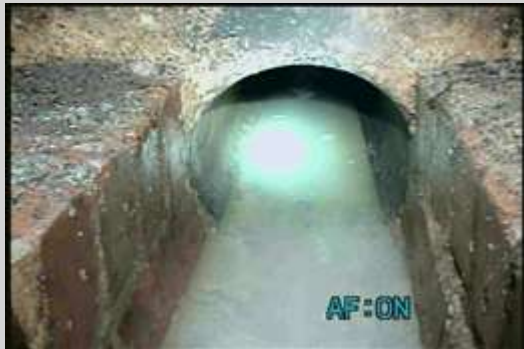
6 O'Clock Inflow

lower pipe in @ 6 oclock

Pipe Material: Clay ☐ Pipe Lined

Invert Depth: 8.83 (ft.) Flow Characteristics: None

Infiltration: None Pipe Seal Cond: Unknown

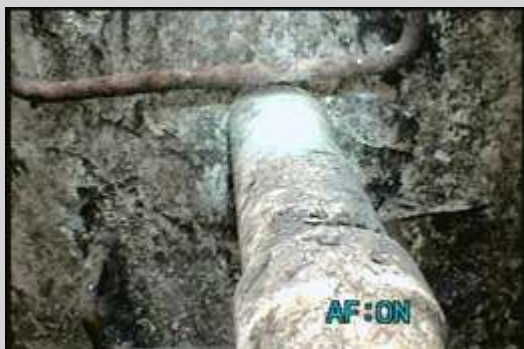
6 O'Clock Inflow

This is the upper pipe in @ 6 oclock (there are 2 pipes in @ 6)

Pipe Material: PVC ☐ Pipe Lined

Invert Depth: 5.54 (ft.) Flow Characteristics: Fast

Infiltration: None

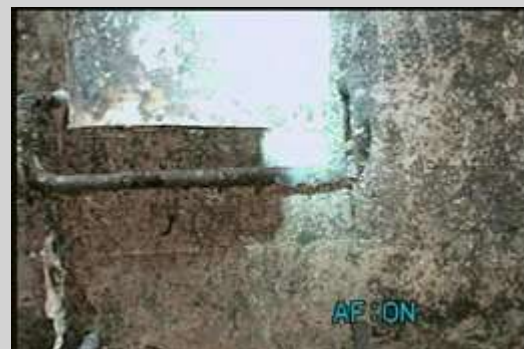
Drop In @ 6 O'Clock

inside drop from upper pipe to channel

Drop: Inside Direct

Drop Condition: Open
